MASSACHUSETTS COASTAL BASIN
PEABODY, MASSACHUSETTS

FOUNTAIN POND DAM
MA 00191

PHASE I INSPECTION REPORT
NATIONAL DAM INSPECTION PROGRAM

OCTOBER 1979

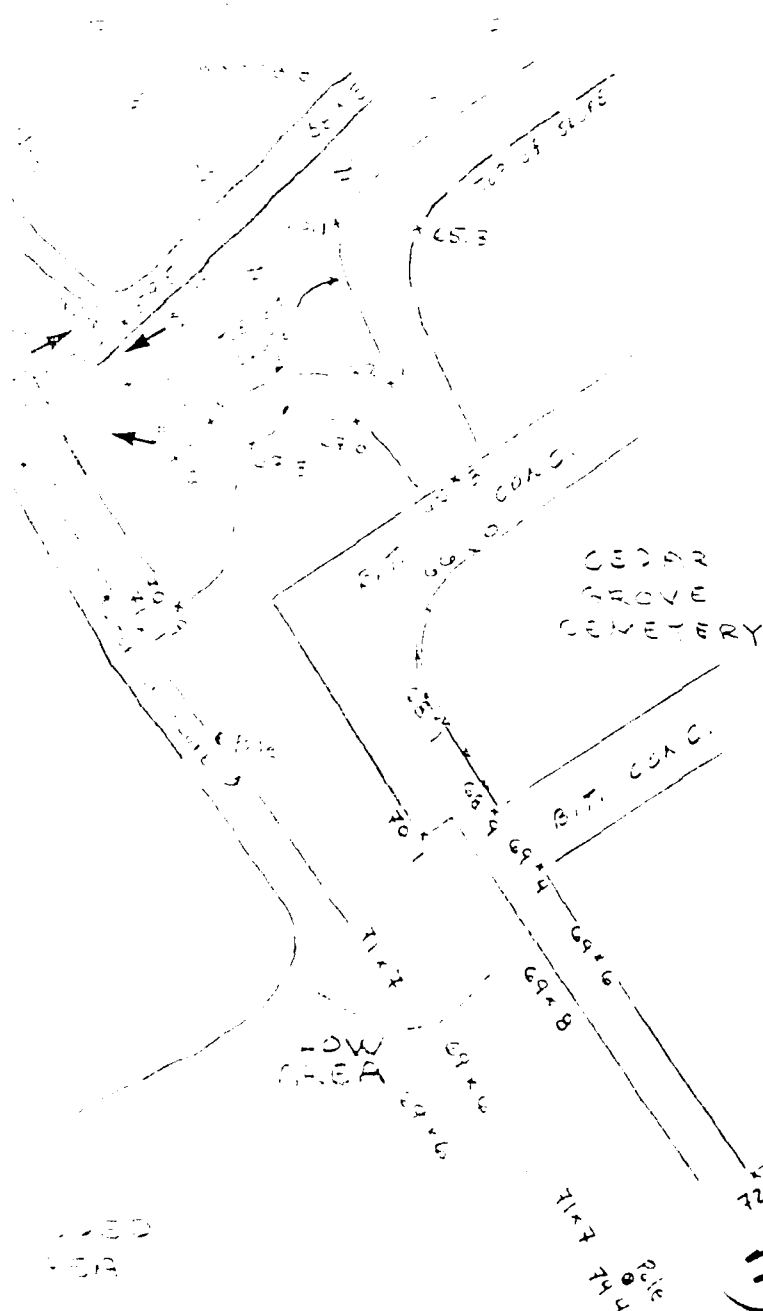
METCALF & EDDY, INC. ENGINEERS BOSTON, MA.	U.S. ARMY ENGINEER DIV. NEW ENGLAND CORPS OF ENGINEERS BALTIMORE, MD.
NATIONAL PROGRAM OF INSPECTION OF NON-FED DAMS	
FOUNTAIN POND DAM	
FIGURE B-1 PLAN OF DAM	
TRIBUTARY NORTH RIVER	MASSACHUSETTS
SCALE: 1" = 50'	DATE: MAY, 1978
